# **SITE RE-ASSESSMENT / PRE- CERCLIS SITE SCREENING / DESK TOP REVIEW REPORTS**

Former St. Louis Lead and Zinc Smelters and  
Processing Sites  
St. Louis, Missouri

August 31, 2006

Missouri Department of Natural Resources  
Division of Environmental Quality  
Hazardous Waste Program

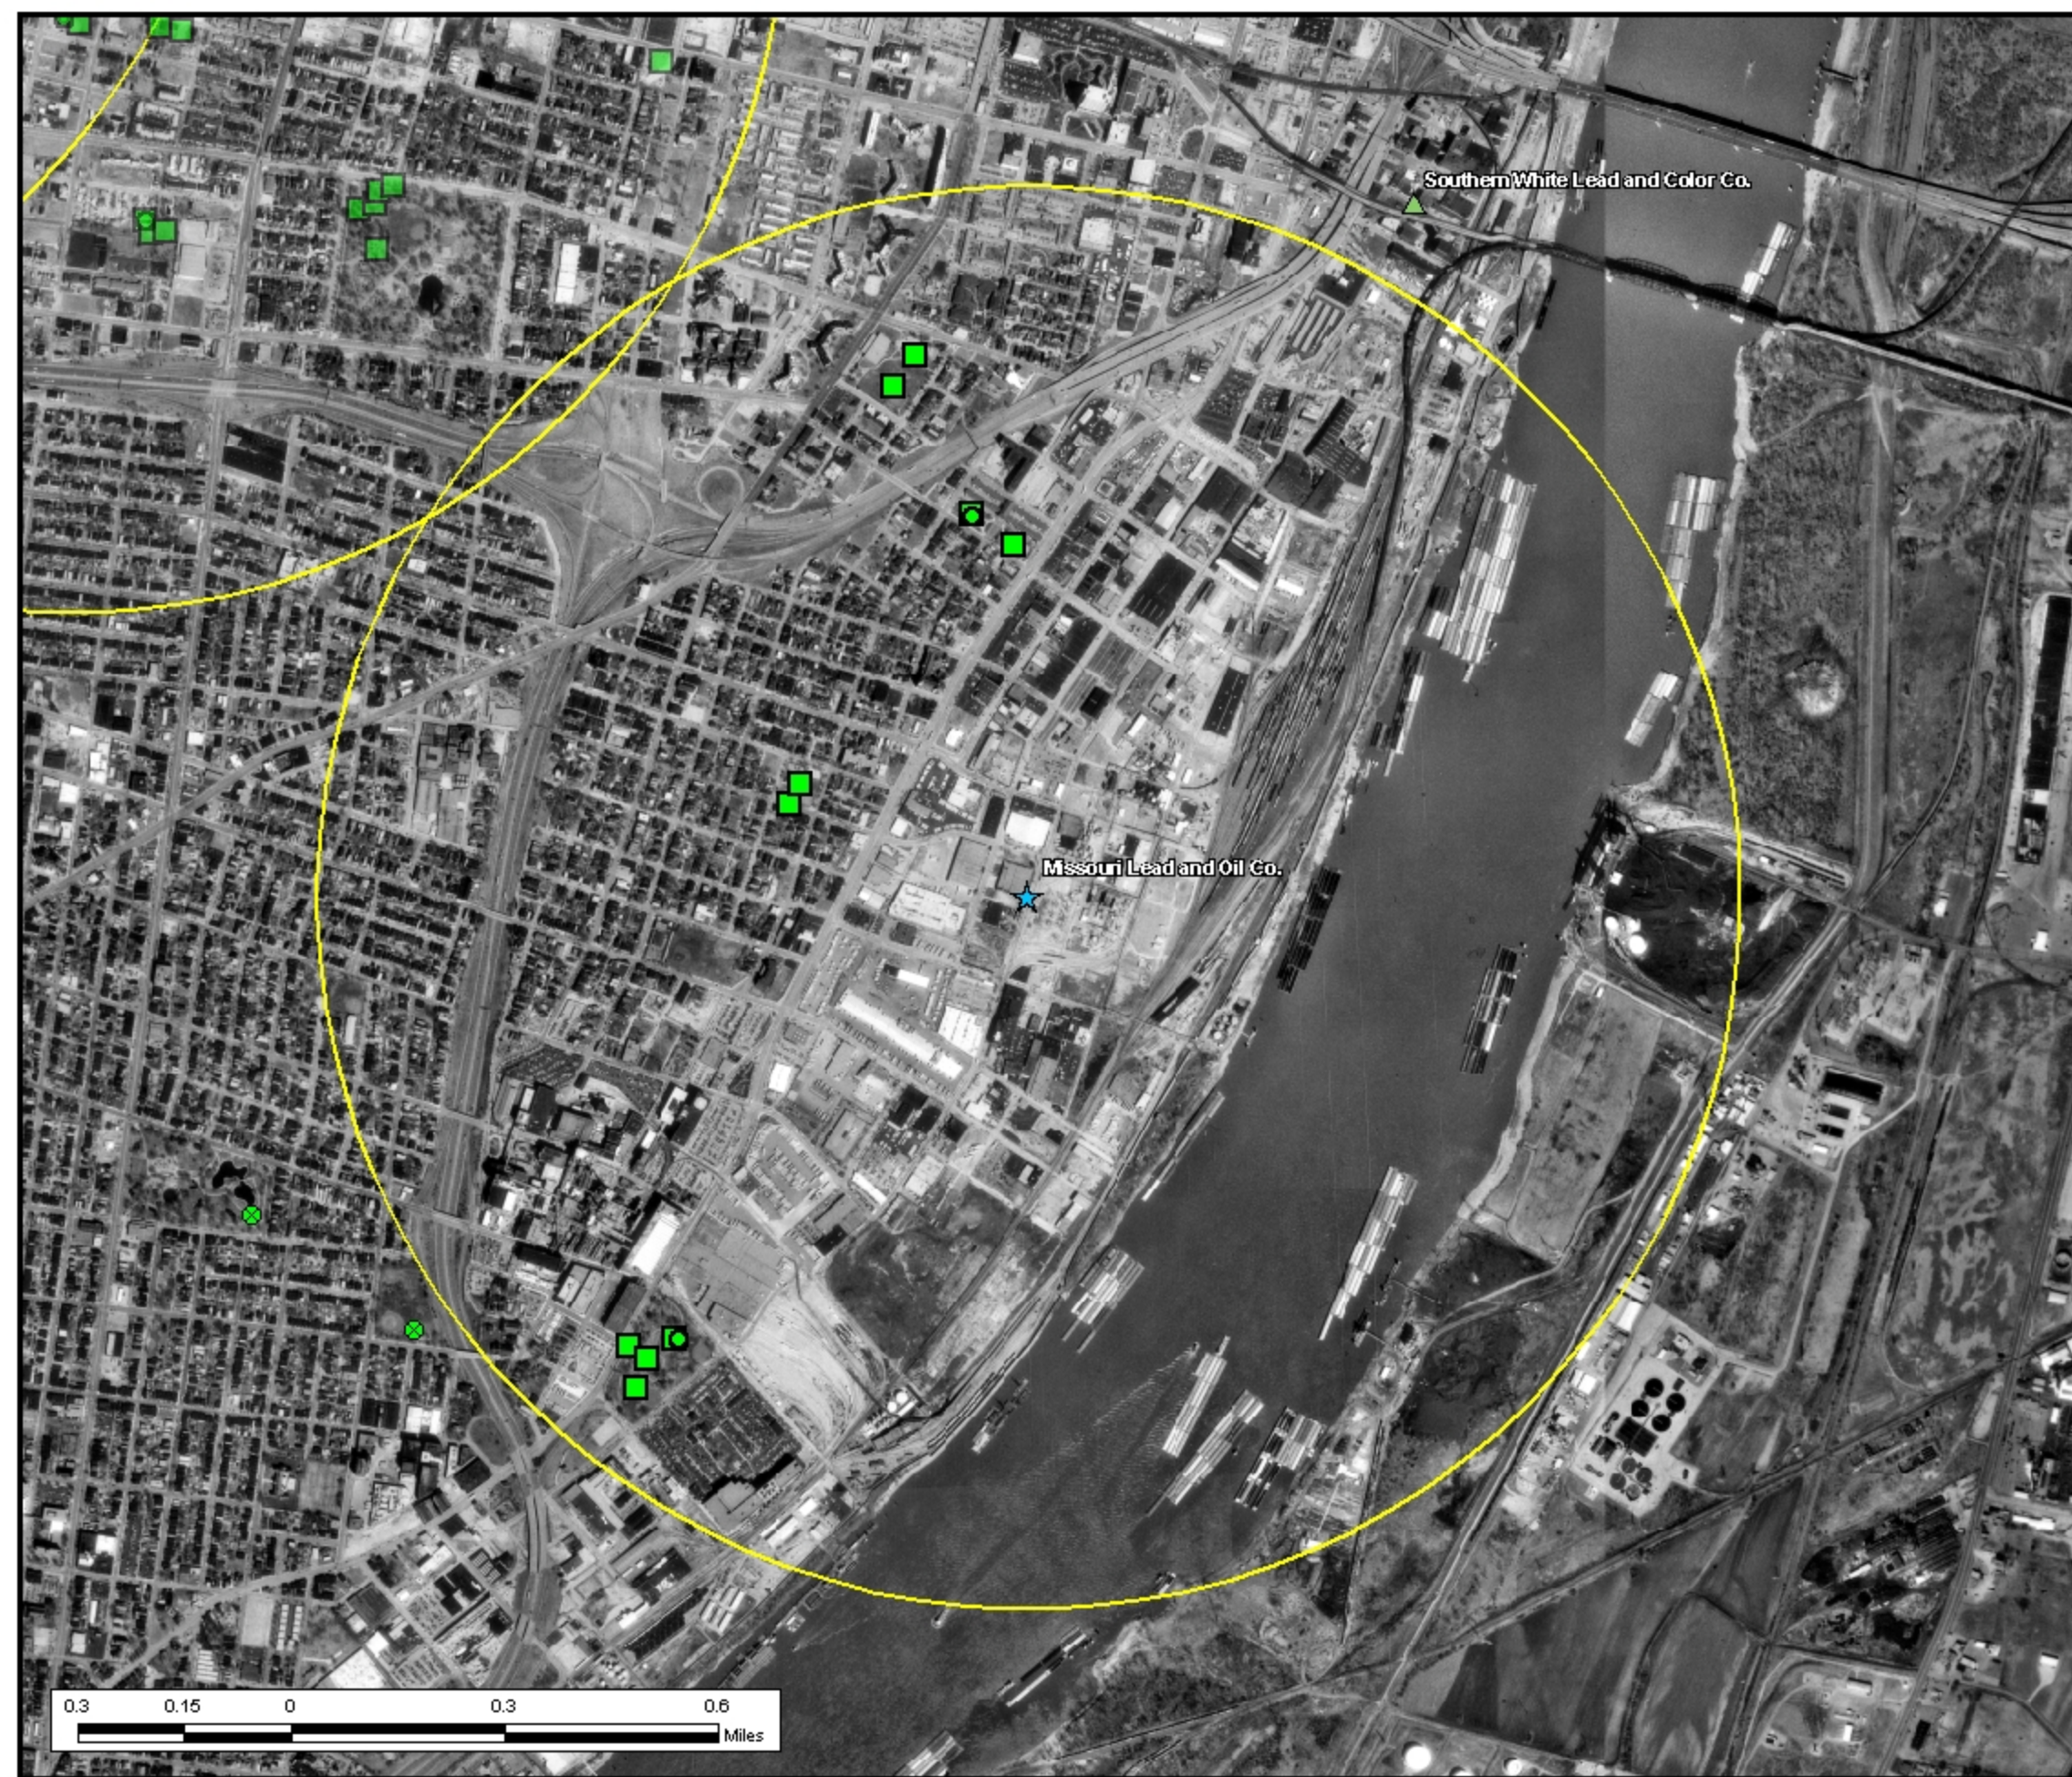
**Figure 1**

Missouri Lead & Oil Co.  
St. Louis City, MO

Figure 1 in Appendix A is a site location/sampling map. Photos are included in Appendix B. The site is located in an industrial/residential area of St. Louis City near the intersection of South Trudeau and Kosciusko Street. No former smelter structures remain at the nearest approximation of the facility. An Ameren UE power station resides at this location and a security fence restricts site access. No waste source material was observed throughout the one-mile radius surrounding the facility.

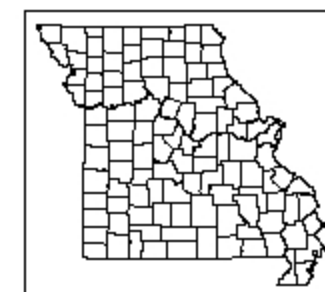
**Project Boundaries**

- One Mile Buffer of Smelter Locations

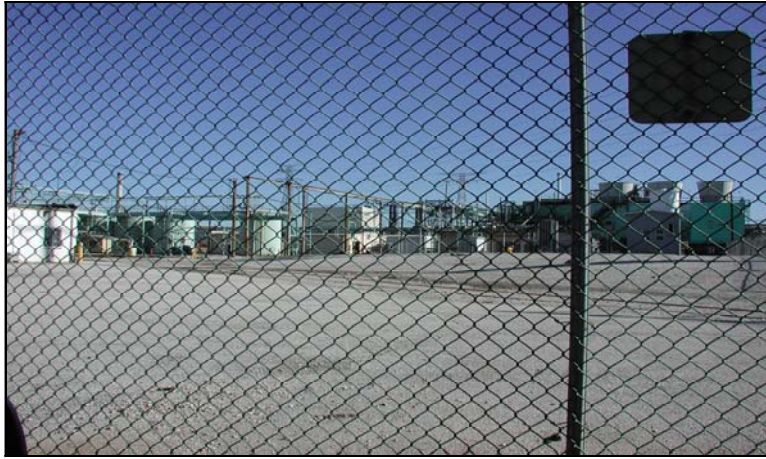
**Photograph 1**

View of AmerenUE Power Station,  
Missouri Lead & Oil Co site area,  
Trudeau Street. View looking northeast.

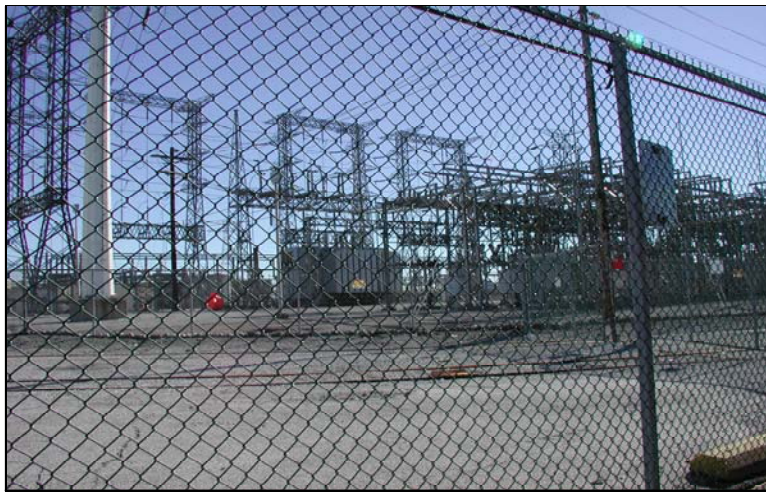
**Photograph 2**

View of AmerenUE Power Station,  
Missouri Lead & Oil Co site area,  
Trudeau Street. View looking southeast.

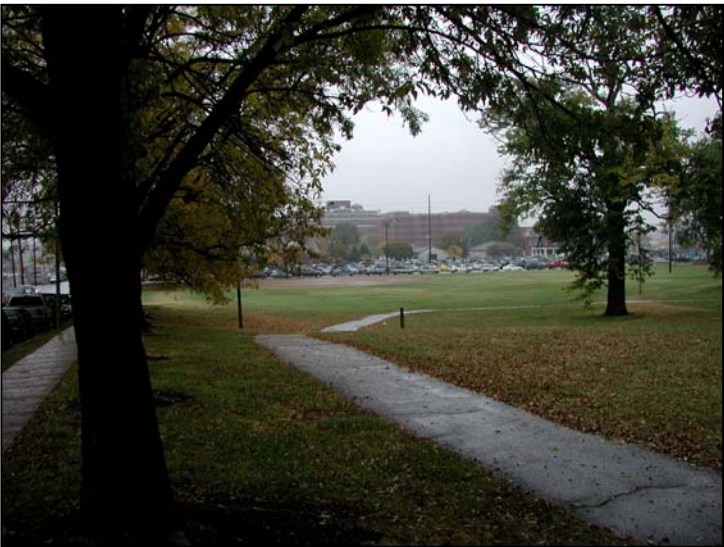
**Photograph 4**

Lyons Park, Sample Location 1. View  
from Arsenal and Broadway St. looking  
south.

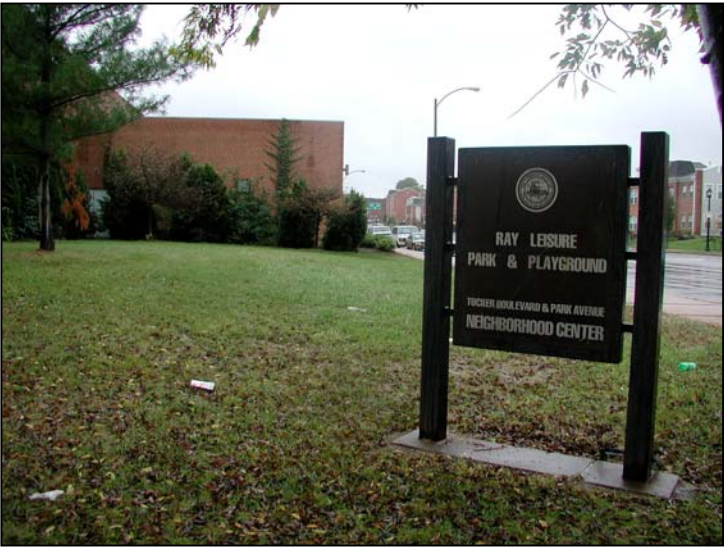
**Photograph 5**

Lyons Park, Sample Location 1. View  
looking southeast from Arsenal and  
Broadway St.

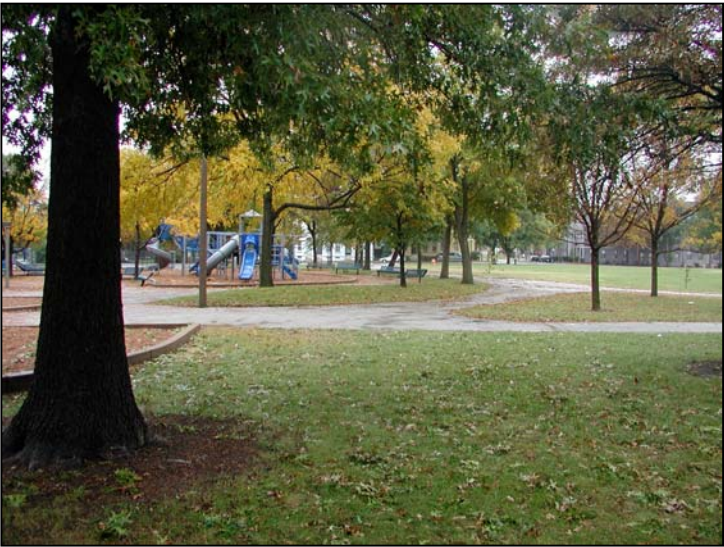
**Photograph 6**

Ray Leisure Park, Sample Location 2.  
View looking southwest from Park Ave.  
and Tucker Blvd.

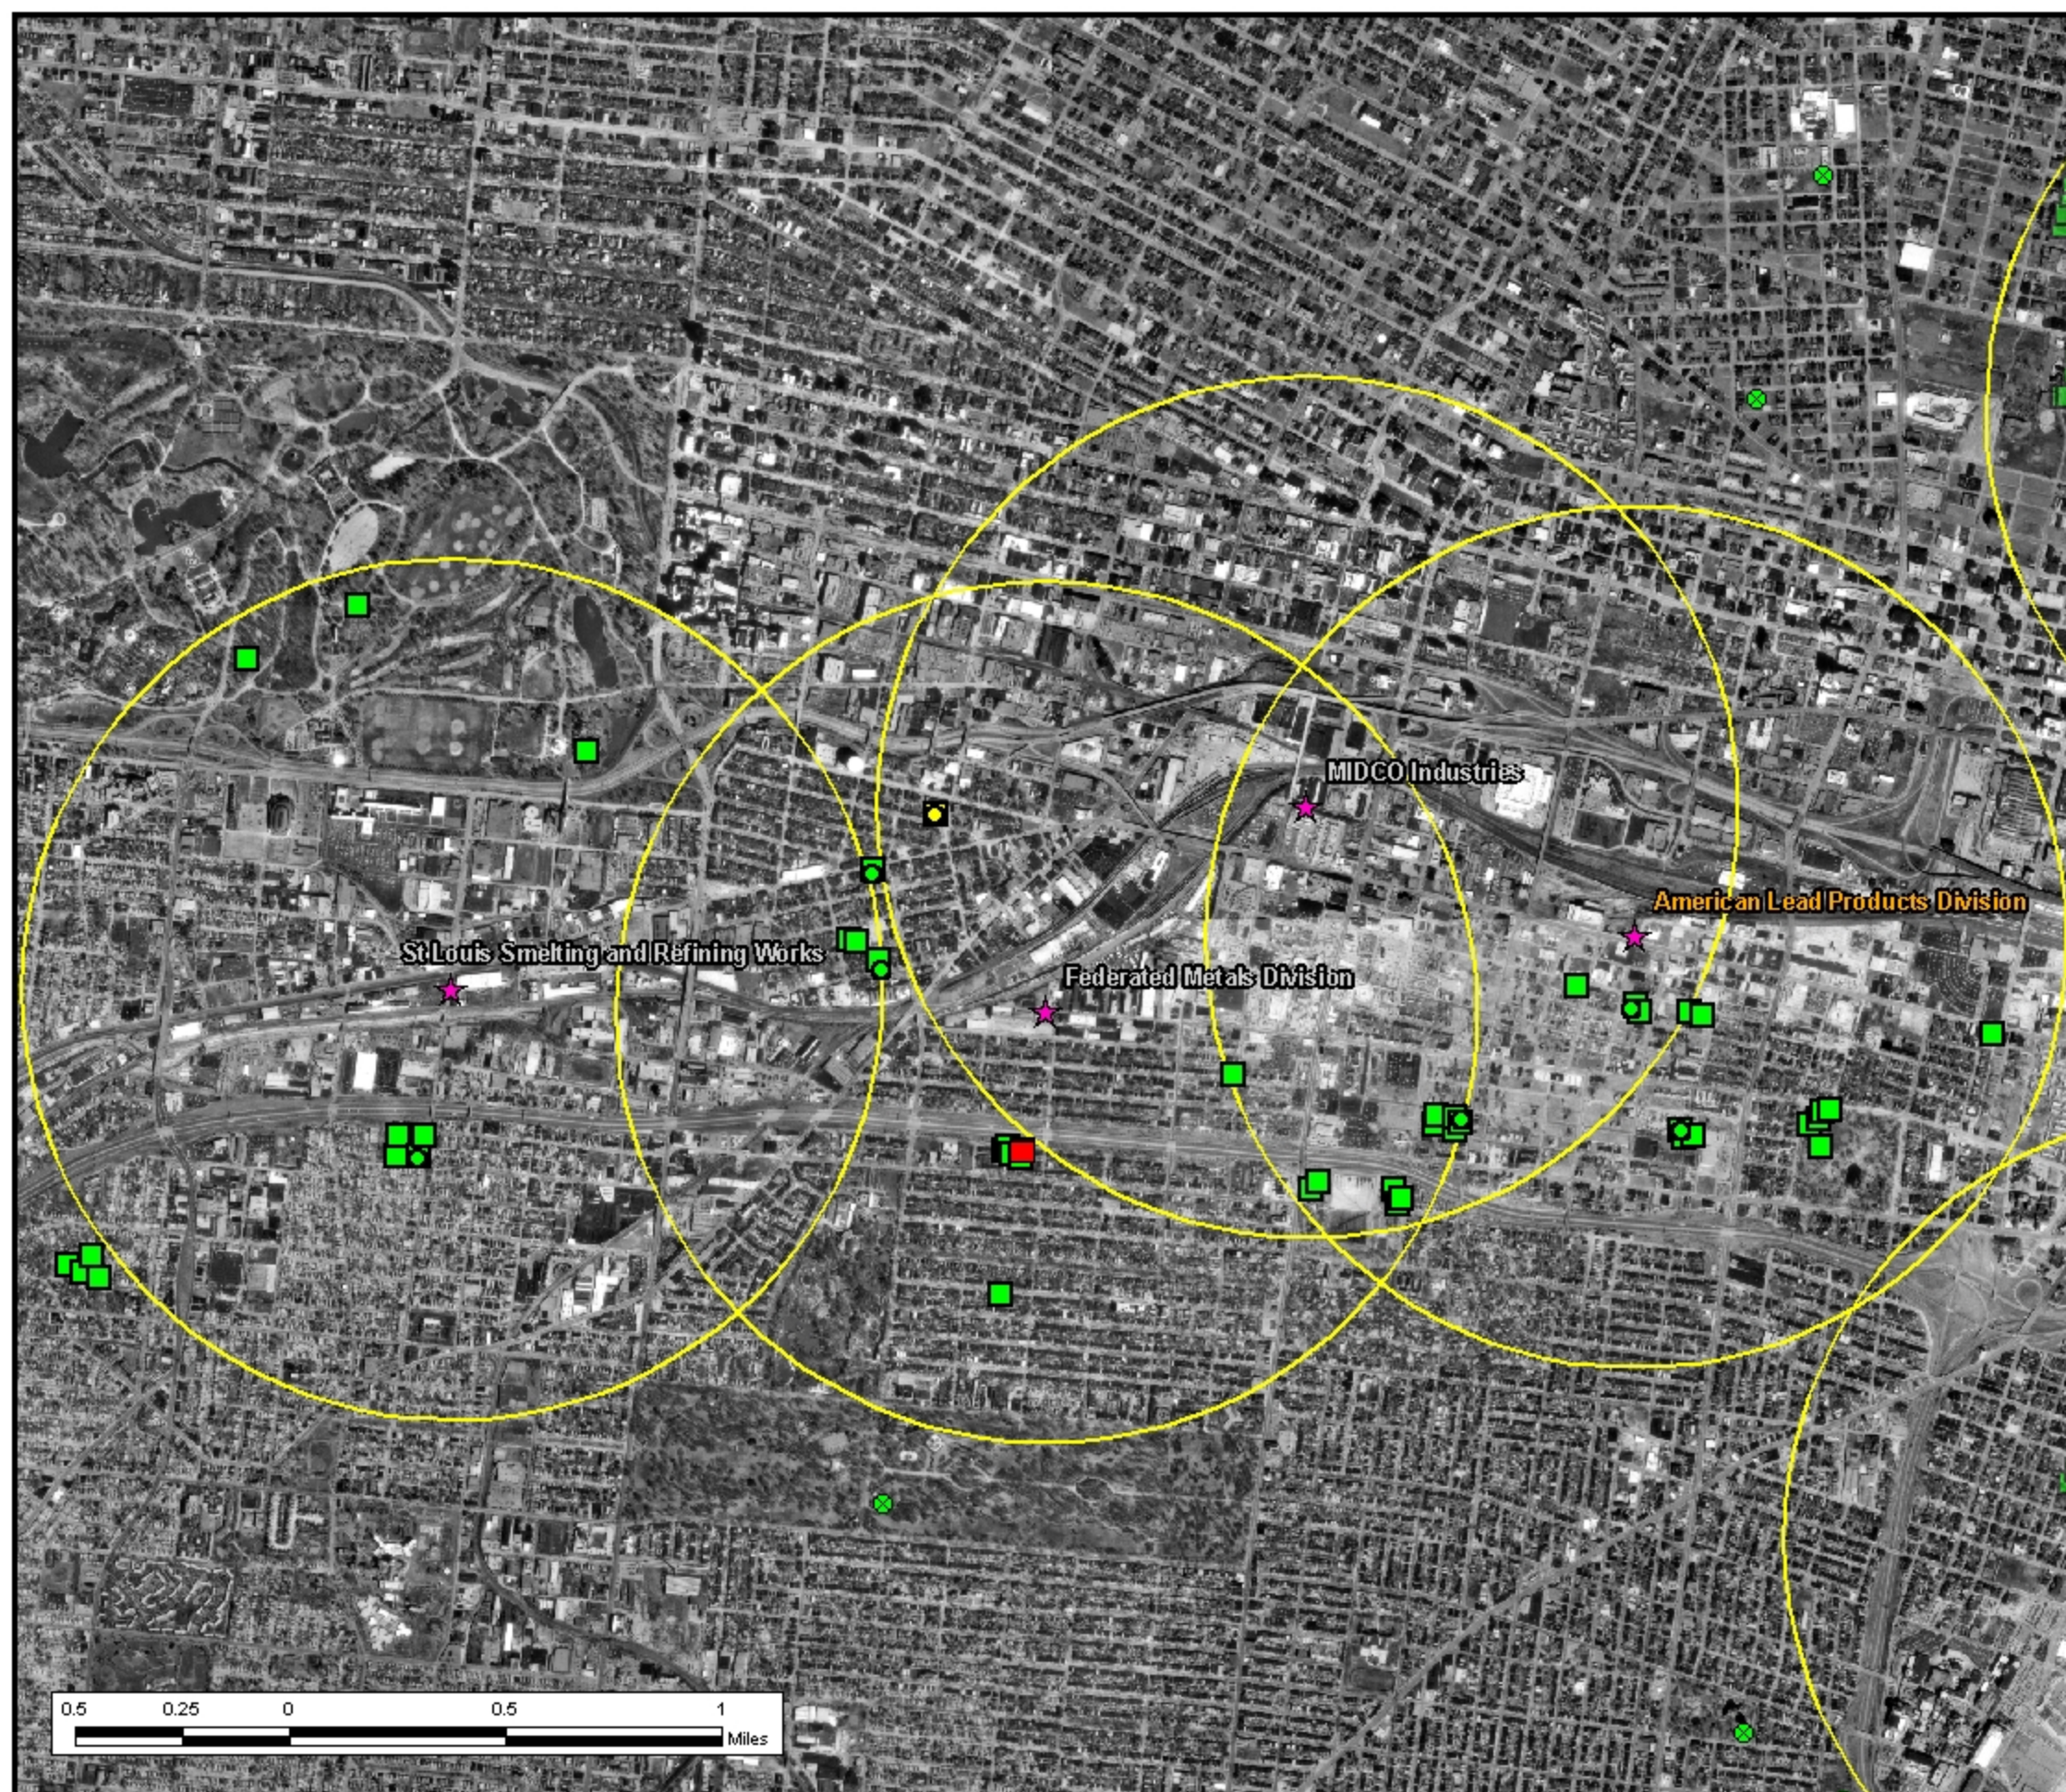
American Lead Products Co., Federated Metals Division,  
MIDCO Industries and St. Louis Smelting & Refining Works  
St. Louis City, MO

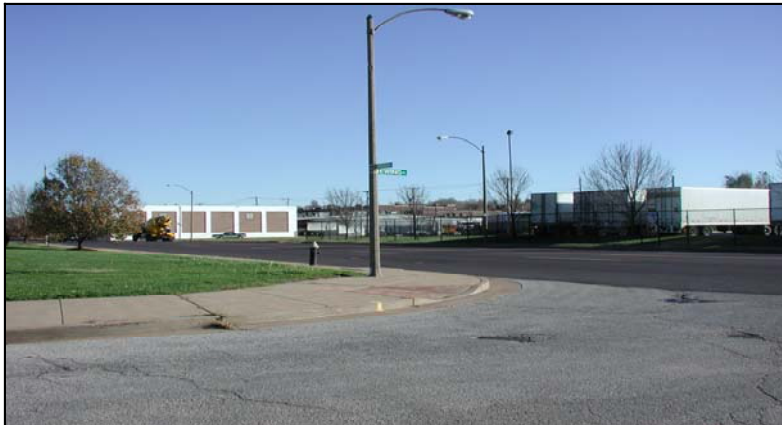
**Photograph 1**

View of American Lead Products Co.  
area, Ewing & Choateau Streets. View  
looking southeast.

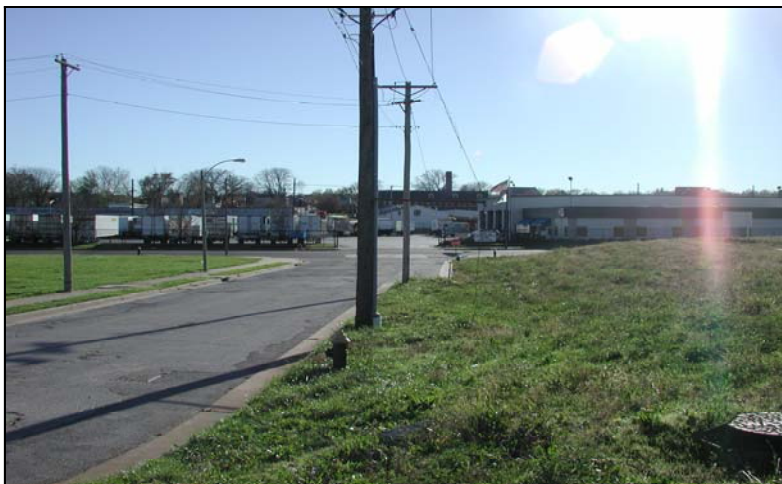
**Photograph 2**

View of neighboring company building  
located in American Lead Products Co.  
area, Ewing, Montrose & Choateau  
Streets. View looking south

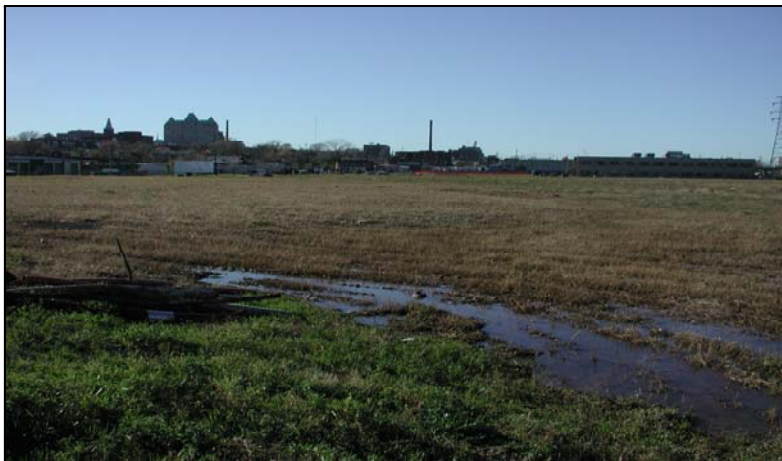
**Photograph 3**

View of neighboring property located in  
American Lead Products Co. area, Ewing,  
Montrose & Choateau Streets. View  
looking southwest.

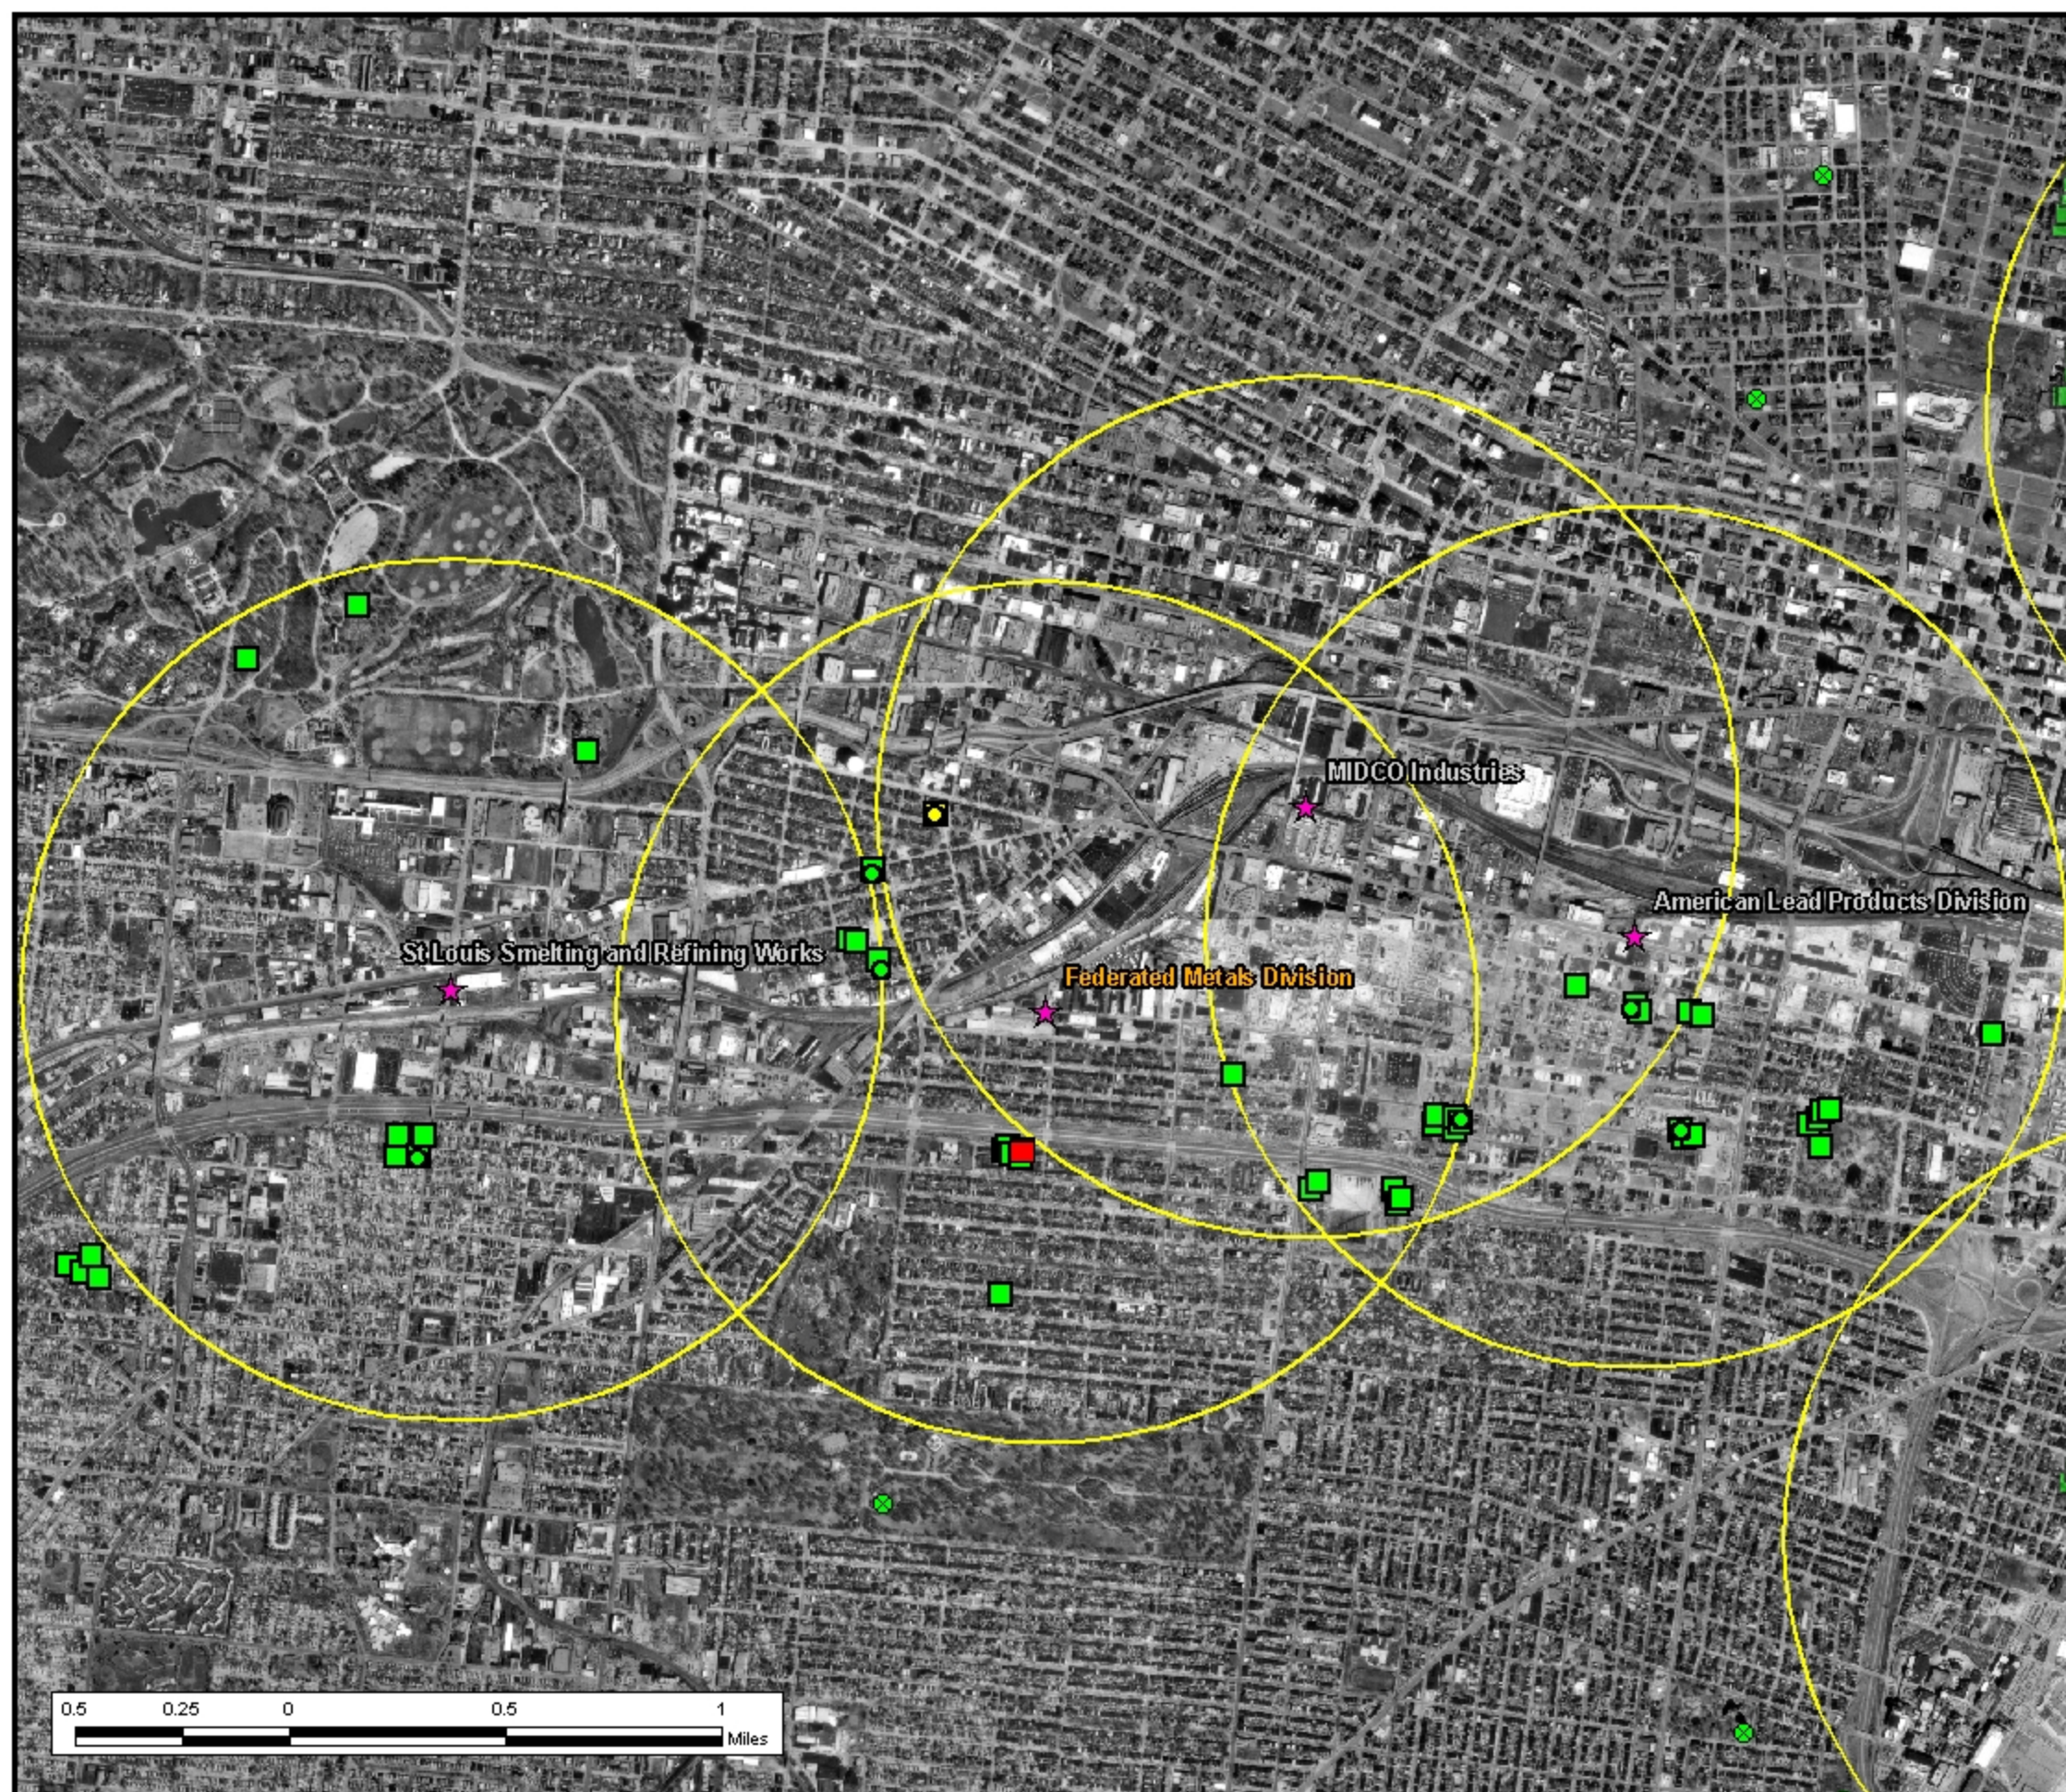
American Lead Products Co., Federated Metals Division,  
MIDCO Industries and St. Louis Smelting & Refining Works  
St. Louis City, MO

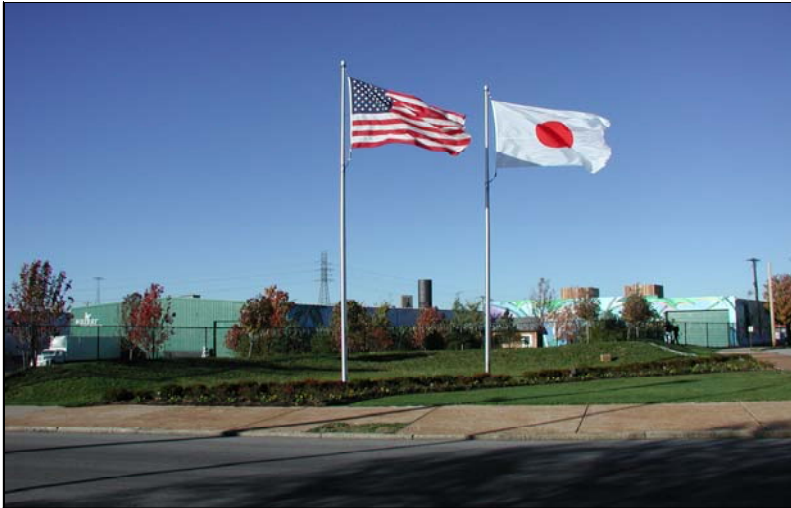
**Photograph 1**

View of neighboring property located in  
Federated Metals Division site area.  
View looking northwest.

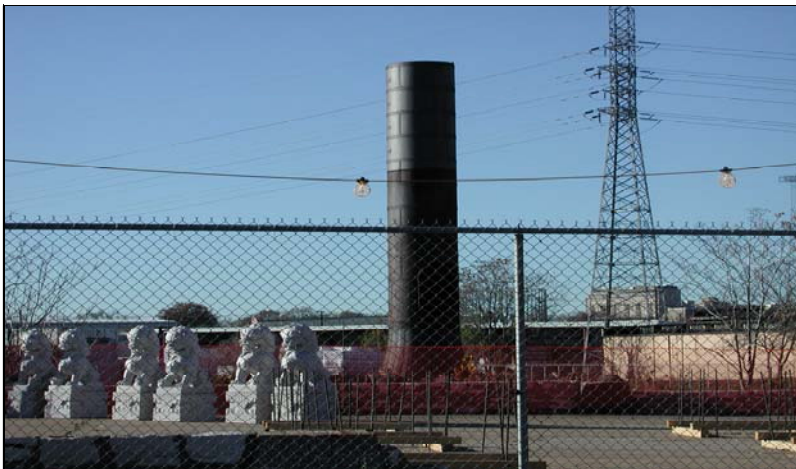
**Photograph 2**

View of a smoke stack on neighboring  
property located in Federated Metals  
Division site area. View looking west.

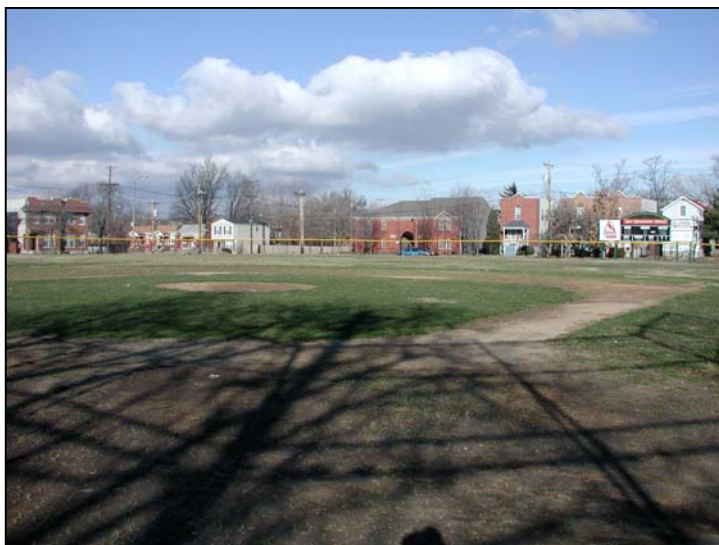
**Photograph 15**

Federated Metals Division Site,  
St. Louis, Missouri. Photo taken on January  
27, 2005 by Rebecca Wells-Albers, DEQ,  
HWP, Superfund

Adams Park, view of sampling location 7.  
View is facing northwest from Vista  
Avenue.

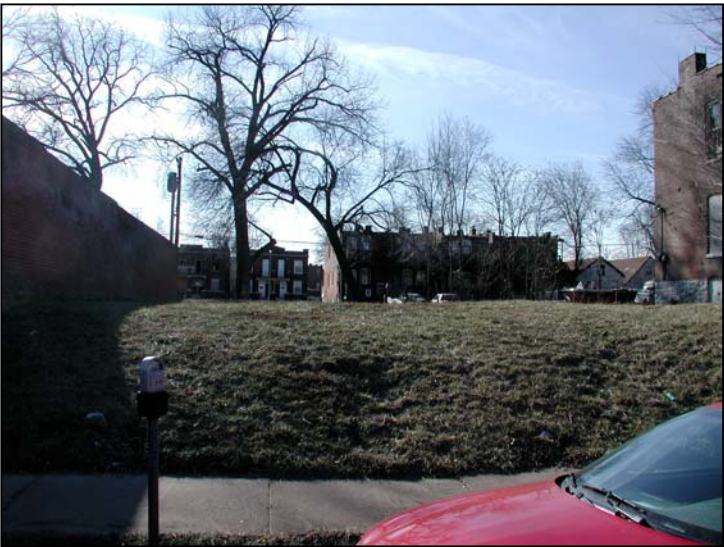
**Photograph 16**  
Federated Metals Division Site,  
St. Louis, Missouri. Photo taken on January  
27, 2005 by Rebecca Wells-Albers, DEQ,  
HWP, Superfund

4312 Manchester Avenue, view of sampling  
location 8. View is facing southeast from  
Manchester Avenue.

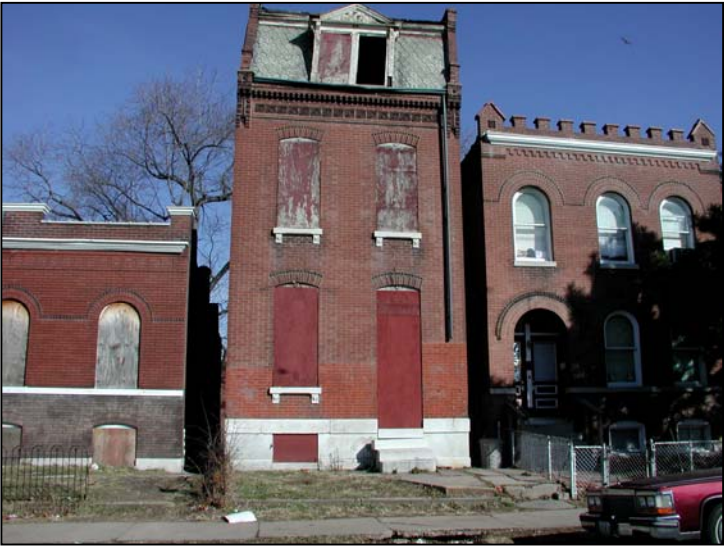
**Photograph 17**  
Federated Metals Division Site,  
St. Louis, Missouri. Photo taken on January  
27, 2005 by Rebecca Wells-Albers, DEQ,  
HWP, Superfund

4311 Gibson Avenue, view of sampling  
location 9. View is facing southeast from  
alley north of Gibson Avenue.

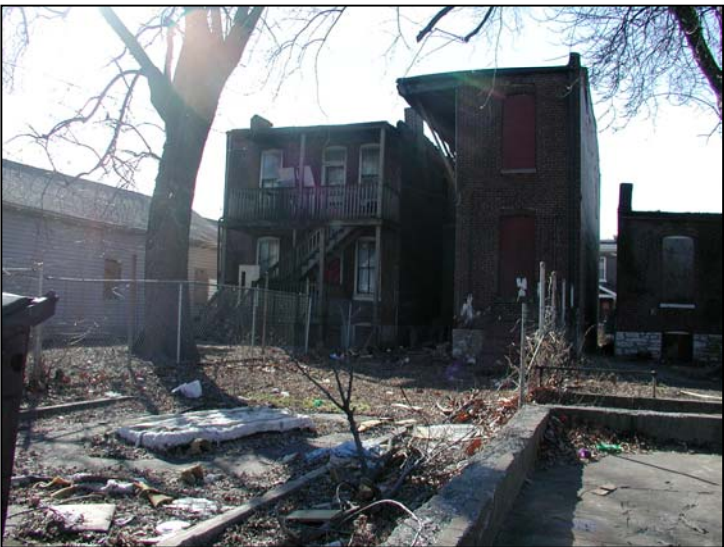
**Photograph 18**  
Federated Metals Division Site,  
St. Louis, Missouri. Photo taken on January  
27, 2005 by Rebecca Wells-Albers, DEQ,  
HWP, Superfund

4311 Gibson Avenue, view of sampling  
location 9. View is facing southeast from  
alley north of Gibson Avenue.

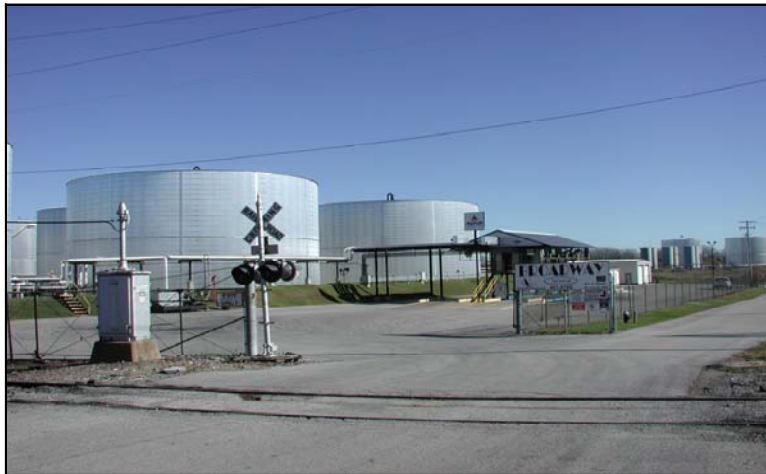
**Photograph 1**

Glendale Zinc Works Site,  
St. Louis, Missouri. Photo taken on  
November 19, 2003 by Michael D.  
Giovanini, DEQ, HWP, Superfund

View of Citco Asphalt Plant, Glendale  
Zinc Works site area, Nagel Ave &  
Wharf. View looking northeast.

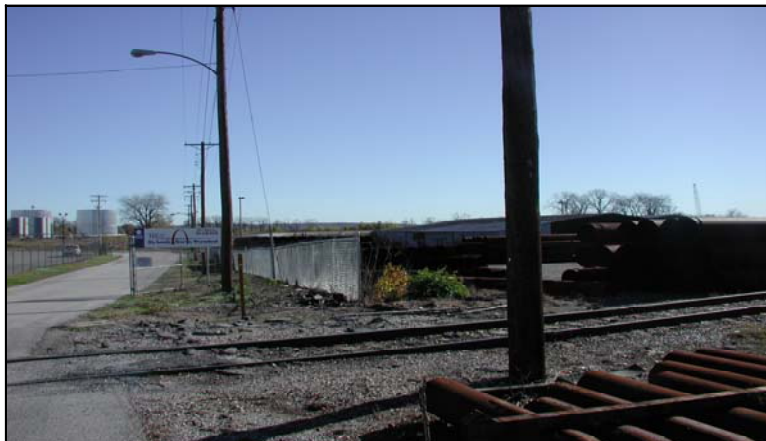
**Photograph 2**

Glendale Zinc Works Site,  
St. Louis, Missouri. Photo taken on  
November 19, 2003 by Michael D.  
Giovanini, DEQ, HWP, Superfund.

View of St. Louis Barge Terminal  
Property, Glendale Zinc Works site area,  
Nagel Ave & Wharf. View looking  
southeast.

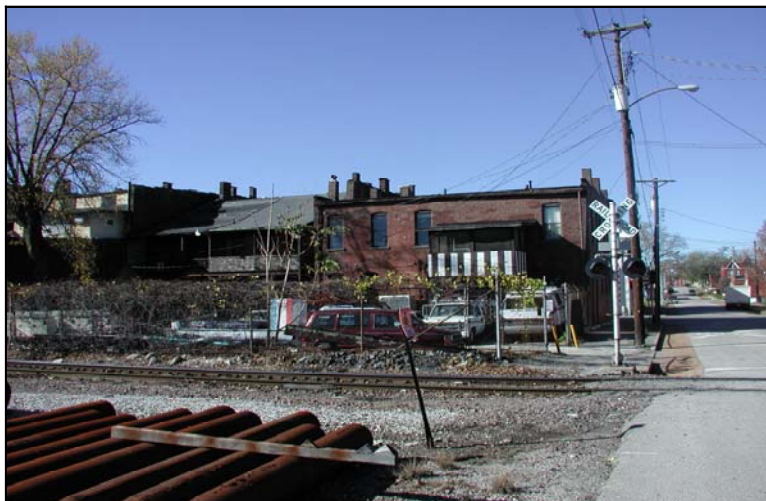
**Photograph 3**

Glendale Zinc Works Site,  
St. Louis, Missouri. Photo taken on  
November 19, 2003 by Michael D.  
Giovanini, DEQ, HWP, Superfund

View of residential property located  
west of Glendale Zinc Works site area,  
Nagel Ave & Wharf. View looking  
west.

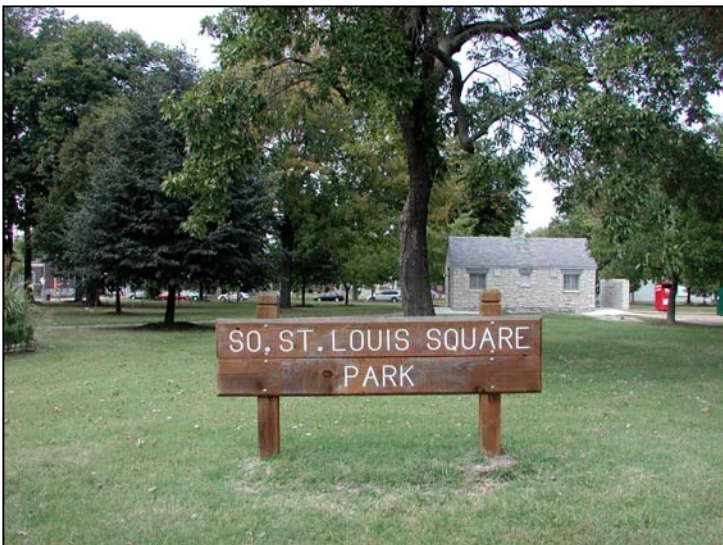
**Photograph 4**

Glendale Zinc Works Site,  
St. Louis, Missouri. Photo taken on  
September 28, 2004 by Michael D.  
Giovanini, DEQ, HWP, Superfund

View of So. St. Louis Square Park,  
Sample location 1, Broadway Ave &  
Courtois St. View looking northwest.

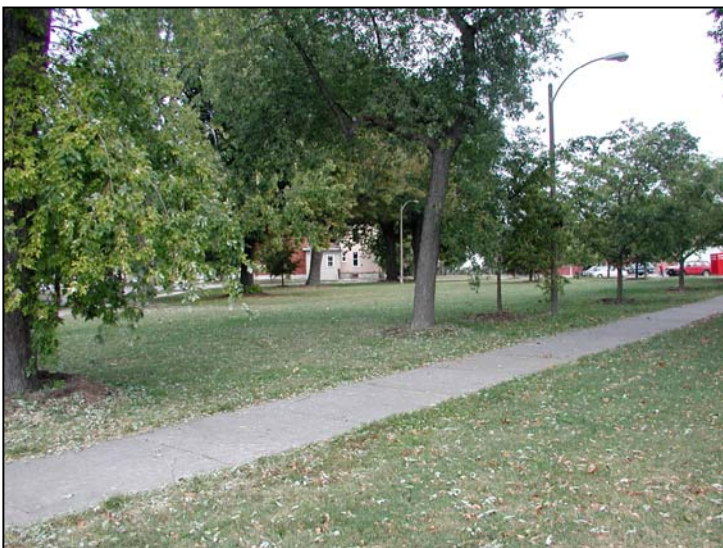
**Photograph 5**

Glendale Zinc Works Site,  
St. Louis, Missouri. Photo taken on  
September 28, 2004 by Michael D.  
Giovanini, DEQ, HWP, Superfund.

View of So. St. Louis Square Park,  
Sample Location 1. View looking south  
from Schrimmer St. and Pennsylvania St.

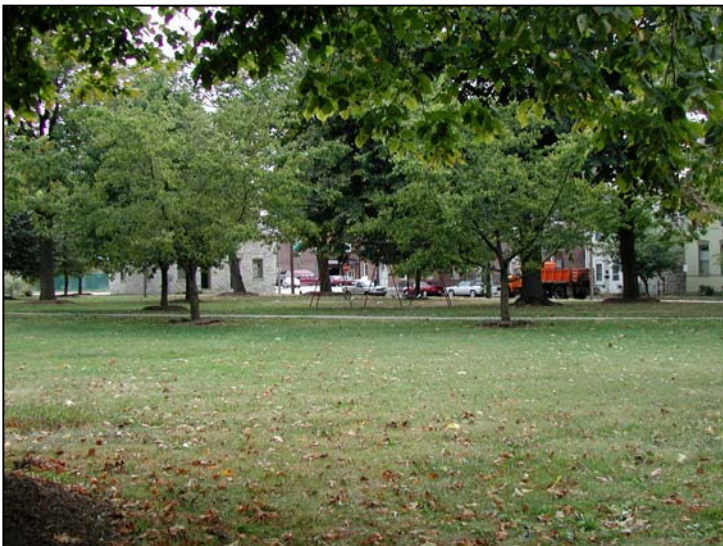
**Photograph 6**

Glendale Zinc Works Site,  
St. Louis, Missouri. Photo taken on  
September 28, 2004 by Michael D.  
Giovanini, DEQ, HWP, Superfund

View of So. St. Louis Square Park,  
Sample Location 1. View looking  
southeast from Pennsylvania St.

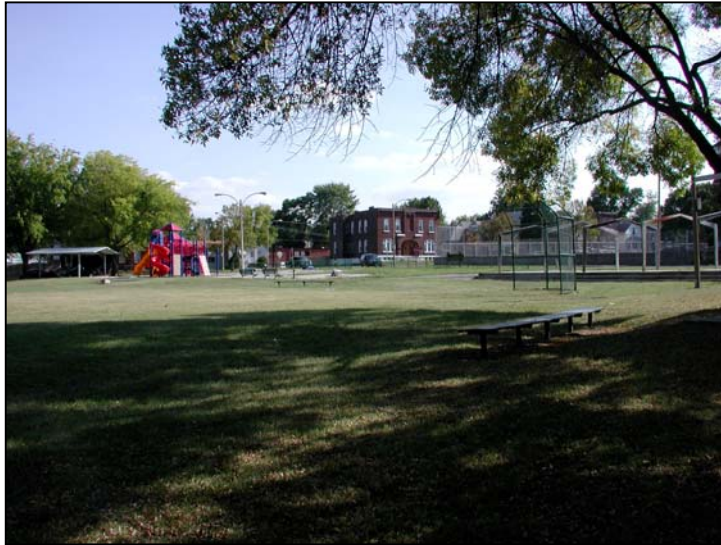
**Photograph 7**

Glendale Zinc Works Site,  
St. Louis, Missouri. Photo taken on  
November 22, 2004 by Michael D.  
Giovanini, DEQ, HWP, Superfund

View of Carondelet Lions Park, Sample  
location 2. View looking southeast from  
Virginia St..

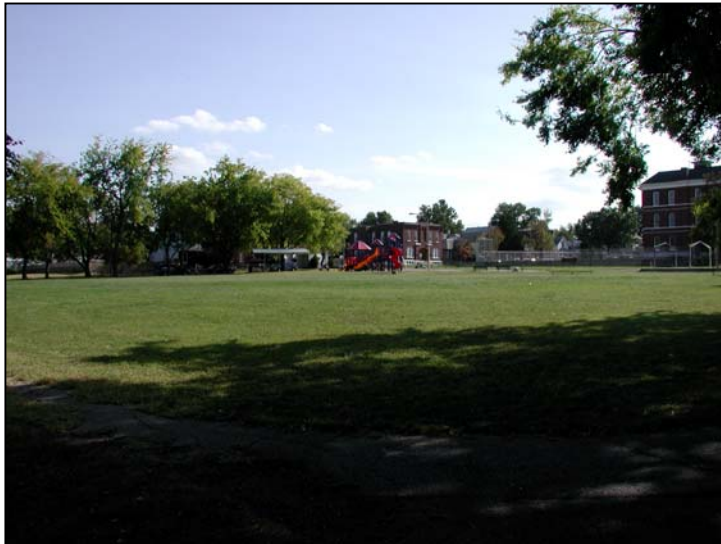
**Photograph 8**

Glendale Zinc Works Site,  
St. Louis, Missouri. Photo taken on  
November 22, 2004 by Michael D.  
Giovanini, DEQ, HWP, Superfund

View of Carondelet Lions Park, Sample  
Location 2. View looking south from  
Poepping St. and Virginia St.

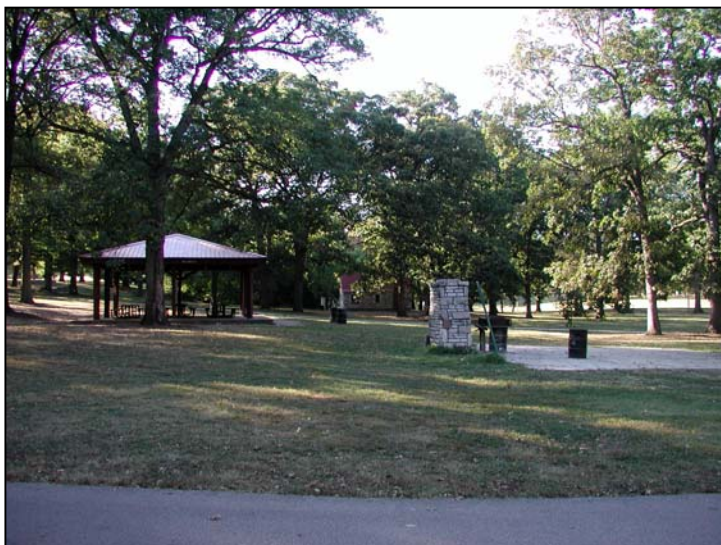
**Photograph 9**

Glendale Zinc Works Site,  
St. Louis, Missouri. Photo taken on  
November 19, 2004 by Michael D.  
Giovanini, DEQ, HWP, Superfund.

View of Carondelet Park, Sample  
Location 3. View looking west from  
Arendes St.

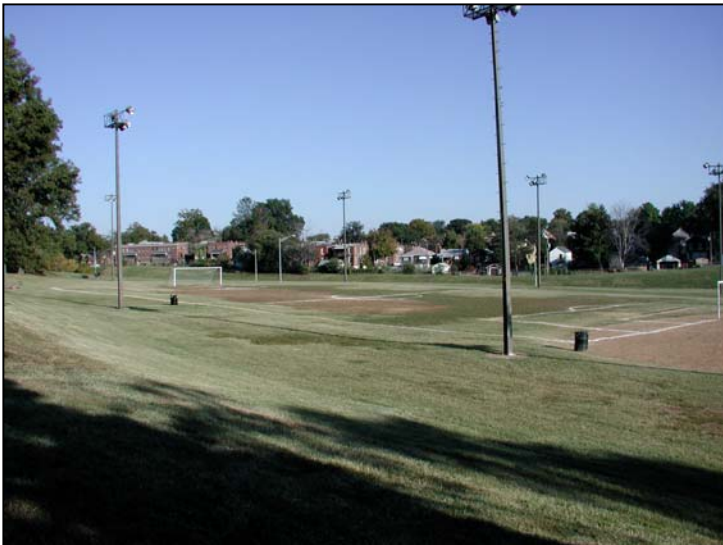
**Photograph 10**

Glendale Zinc Works Site,  
St. Louis, Missouri. Photo taken on  
November 19, 2004 by Michael D.  
Giovanini, DEQ, HWP, Superfund

View of Carondelet Park, Sample  
Location 3. Nagel Ave & Wharf. View  
looking northeast towards soccer field.

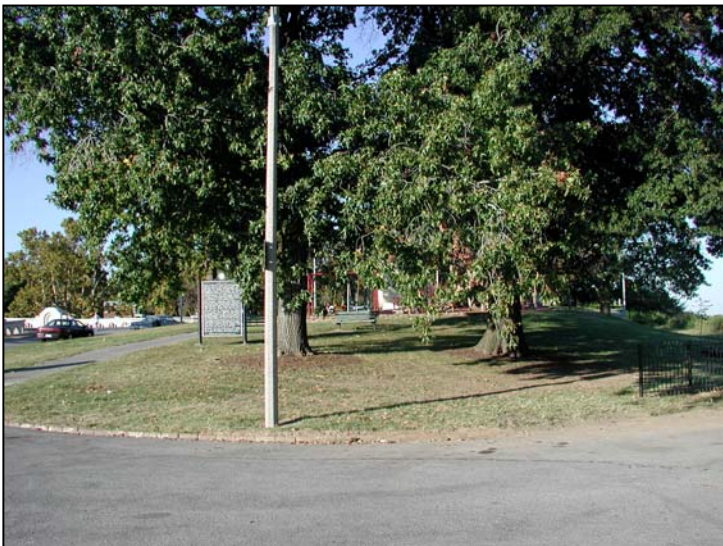
**Photograph 11**

Glendale Zinc Works Site,  
St. Louis, Missouri. Photo taken on  
November 19, 2004 by Michael D.  
Giovanini, DEQ, HWP, Superfund

View of Bellerive Park, Sample location  
4. View front entrance.

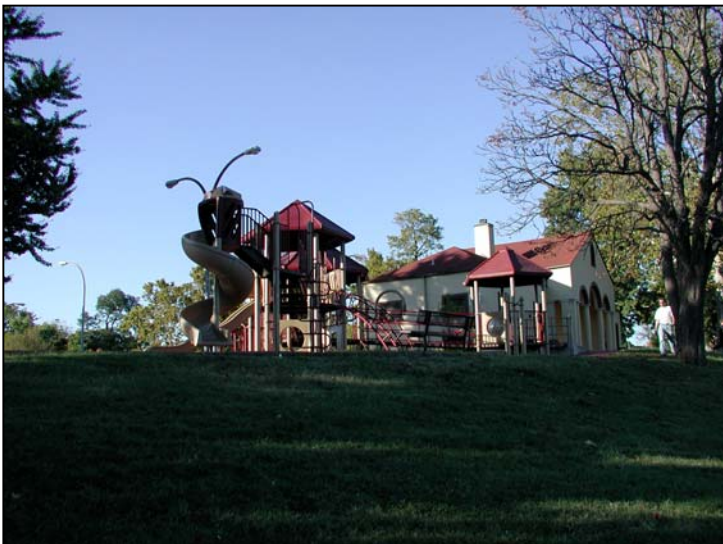
**Photograph 12**

Glendale Zinc Works Site,  
St. Louis, Missouri. Photo taken on  
November 19, 2004 by Michael D.  
Giovanini, DEQ, HWP, Superfund

View of Bellerive Park, Sample  
Location 4. Broadway and Bellerive  
Blvd.. View looking north.
